Technical Report No. 64.190.12.00108.01B

Test subject: Product: STAGE
Type: TFRASSP4x4, TFRASSP4x8

Test specification: According to the client' s requirements.
Details see Clause 3.

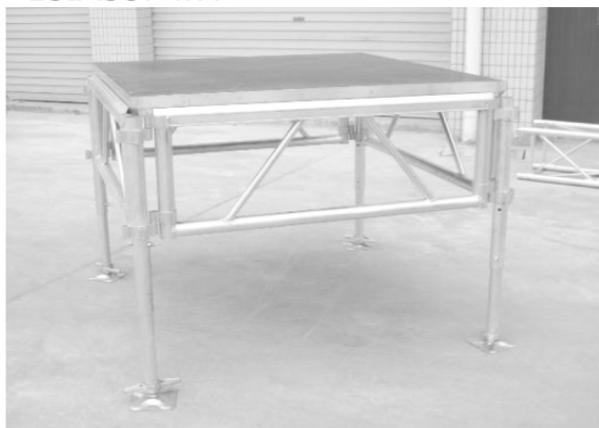
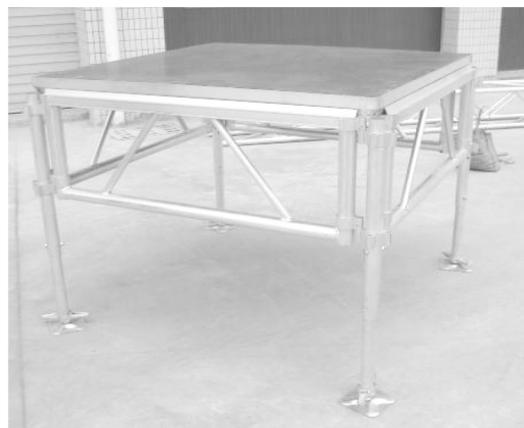
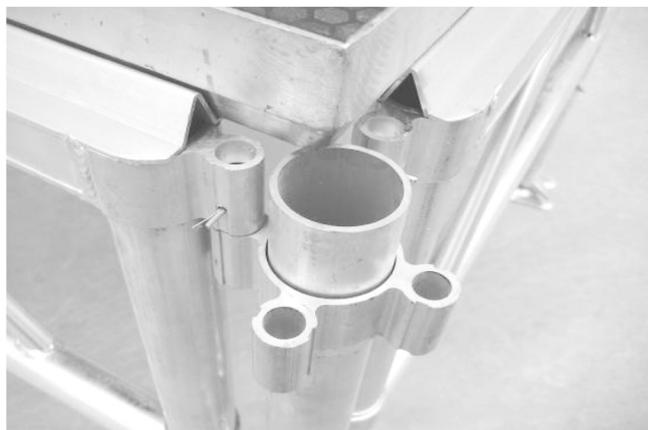
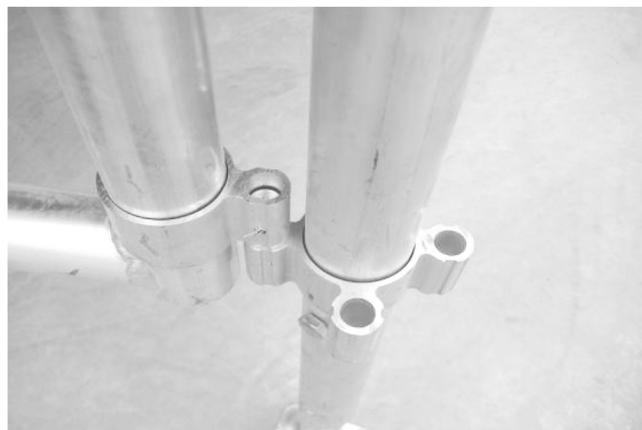
Model: ESIASSP4x4
Platform dimension (L x W): 1220 mm x 1220 mm
Platform height: 800 mm, 1070 mm
Weight: 50,0 kg

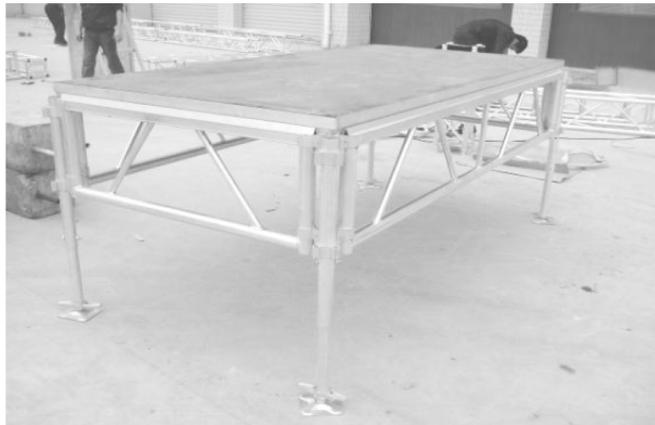
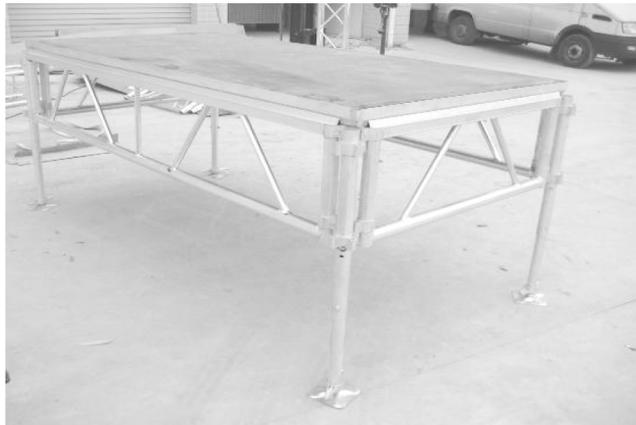
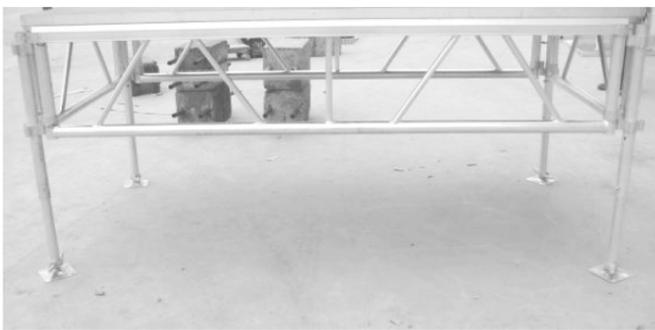
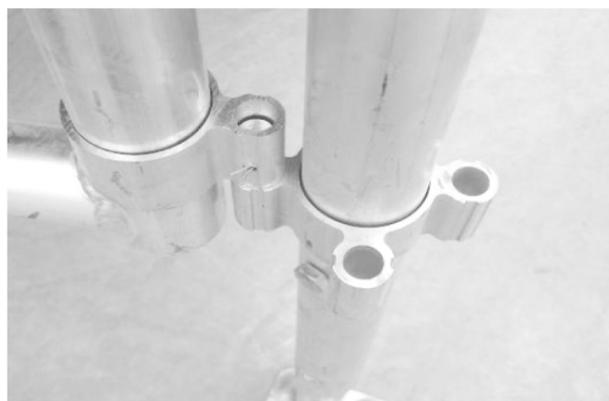
Model: ESIASSP4x8
Platform dimension (L x W): 2440 mm x 1220 mm
Platform height: 800 mm, 1070 mm
Weight: 75,5 kg

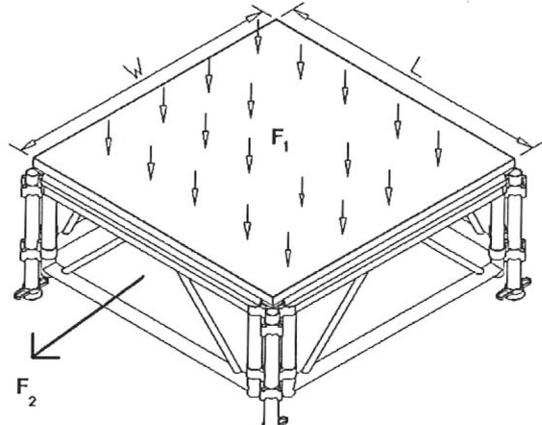
Verdict: P = passed; F = failed; NA = not applicable.			
Clause	Requirement Test	Remark	Verdict
1	<p>Loading test</p> <p>A test vertical load F_1 (see table 1) shall be distributed uniformly applied to the whole surface of the platform for a period of 5 minutes, then applied a horizontal force F_2 of 1000N to the stage tested according to Figure 1.</p> <p>After removal of the test load, the stage platforms shall not show any visible damages such as cracks, indentations etc.</p>

<p style="text-align: center;">Figure 1</p>	No visible damage was found after test.	P

Model	Test load F_1 (kg)
ESIASSP4X4	1000
ESIASSP4X8	1600
